**SPR Research Project C-06-02:**

**Field Evaluations of  
“ShapeAccelArray” In-place MEMS  
Inclinometer Strings for Subsurface  
Deformation Monitoring**

**FINAL REPORT**  
March 2012

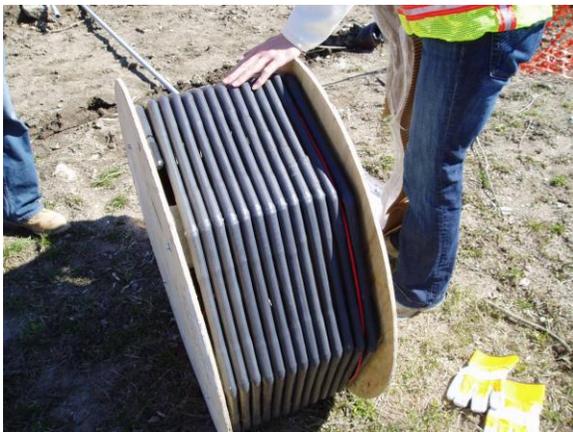
**FIGURE 1: Inclinometer string on shipping reel.**

The systems described in this paper consist of 104 rigid segments, each 1 foot (305 mm) long, connected end-to-end by torque-resistant flexible joints. Refer to Figure 1. Each segment contains three MEMS accelerometers to measure x, y, and z axis tilt. (Only the x and y sensors are needed to calculate the tilt of a segment in a near-vertical orientation; however, for a segment lying in a near-horizontal orientation, the z sensor becomes necessary to attain better accuracy.) By calculating and summing the displacements of segments from the bottom up, the shape of the entire string can be determined, which would resemble the deformed shape of the borehole axis. The system resolution reported by the manufacturer is +/- 0.05 mm/m. This is corroborated by NYSDOT field experience: variations of 0.9 mm in 17 m were observed over a period of six months at one site.

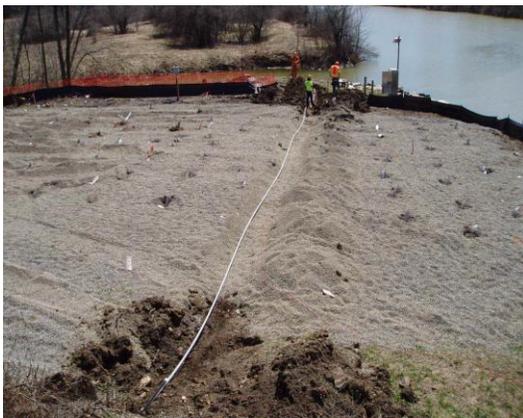
**FIGURE 2: Horizontal inclinometer string installation over wick drain field – Fort Ann.**

The vertical inclinometer string at Fort Ann was installed inside a borehole cased with 2-inch (51 mm) diameter PVC monitoring well casing. The annular space between the instrument and the casing was backfilled with clean sand in order to put the instrument in intimate contact with the ground. At the completion of the monitoring period, the inclinometer string was freed by flushing the sand out of the hole. The horizontal inclinometer string was directly inserted into a “snug”-fitting 1-inch (25 mm) diameter PVC pipe and buried in a small trench running transversely beneath the proposed embankment site. Refer to Figures 2 and 3.

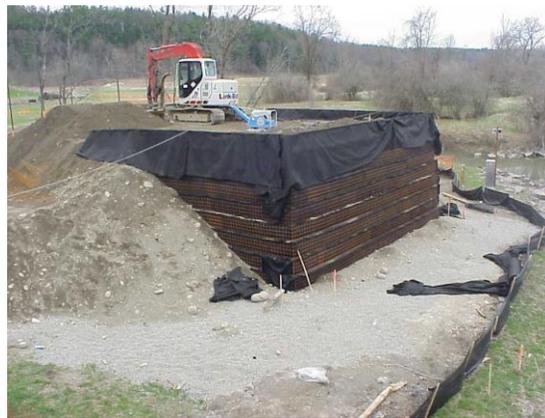
**FIGURE 3: Surcharge construction using geosynthetic reinforced earth wall – Fort Ann.**

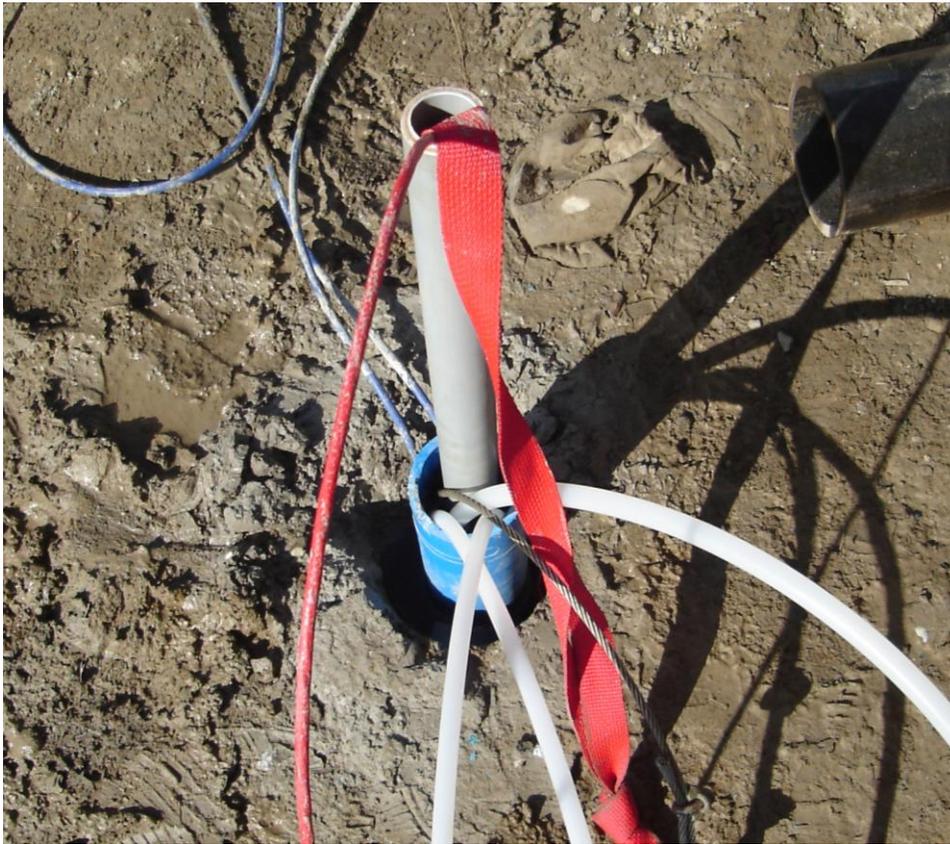
**FIGURE 4: Inclinometer string installation showing 1-inch PVC pipe (gray), 2.75-inch inclinometer casing (blue), instrument lead wire (red), nylon strap (red), and three jetting tubes (white).**

For the second project, the vertical inclinometer string was extracted from Fort Ann and re-used to monitor an active landslide near Springville, New York. The instrument was inserted into a 1-inch (25 mm) PVC pipe before being installed within a borehole cased with ABS inclinometer casing (2.75-inch (70 mm) diameter). Refer to Figure 4. The gap was again backfilled with sand. This installation required inserting the 104-foot (31.7 m) long instrument to a depth of 140 feet (42.7 m) to detect a suspected deeper landslide shear zone. This meant that the 1-inch (25 mm) PVC pipe had to extend about 36 feet (11.0 m) above top of the inclinometer string to reach the ground surface. The field installation did not orient the instrument accurately; however this was simply a result of insufficient planning. It would have been possible to keep track of the instrument alignment by using the markings along the outside of the 1-inch (25 mm) PVC pipe.

The backfilling technique was improved at the Springville site by first inserting the inclinometer string, along with a flat nylon strap, directly into a 1-inch (25 mm) diameter PVC pipe. The nylon strap created a tighter fit and the PVC provided more rigidity to the string. Then the entire assembly (instrument string within PVC pipe) was inserted into the 2.75-inch (70 mm) diameter casing. To make the installation retrievable, the annular space between the 1-inch (25 mm) casing and the 2.75-inch (70 mm) inclinometer casing was backfilled with sand using similar procedures as for the Fort Ann site. The 1-inch PVC pipe seemed to eliminate much of the backfill settlement concern that was detected at the first site. It is possible that this change may have reduced the sensitivity of the instrument. However, since the 1-inch (25 mm) PVC pipe is a smaller diameter and less rigid than the 2.75-inch (70 mm) ABS inclinometer casing, the system would likely still behave relatively flexibly. In fact, the capability of this installation was subsequently verified by its detection of intermediate landslide shear zone displacements along scarps and the deeper basal sliding zone.

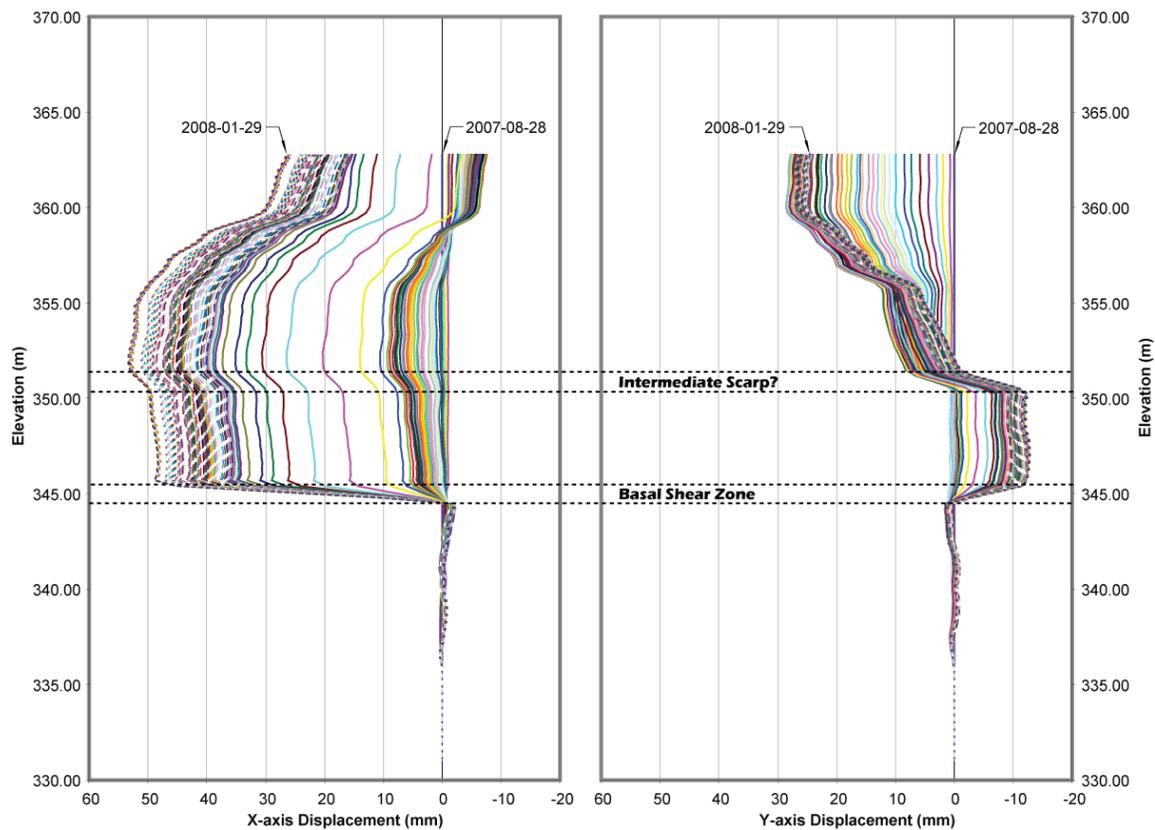
**FIGURE 5: Average daily displacement profile – Springville**

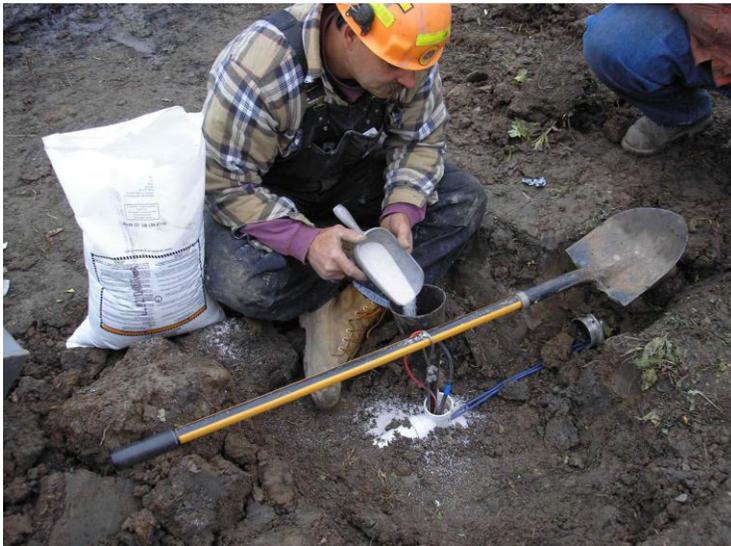
**FIGURE 6: Placing sand backfill by hand.**

backfilling, a 0.125-inch diameter (3 mm) wire-wound steel cable was attached by taping it approximately every 5 feet (1.5 m). A plastic jetting tube (0.375-inch diameter (10 mm)) was also attached along the length of the string to facilitate later removal. After the inclinometer string was inserted, silica sand was slowly funneled into the top of the hole while the top of the casing was struck intermittently with a rubber mallet to prevent the sand from bridging. Refer to Figure 6. No tamping or compactive effort beyond this slight vibration was used.

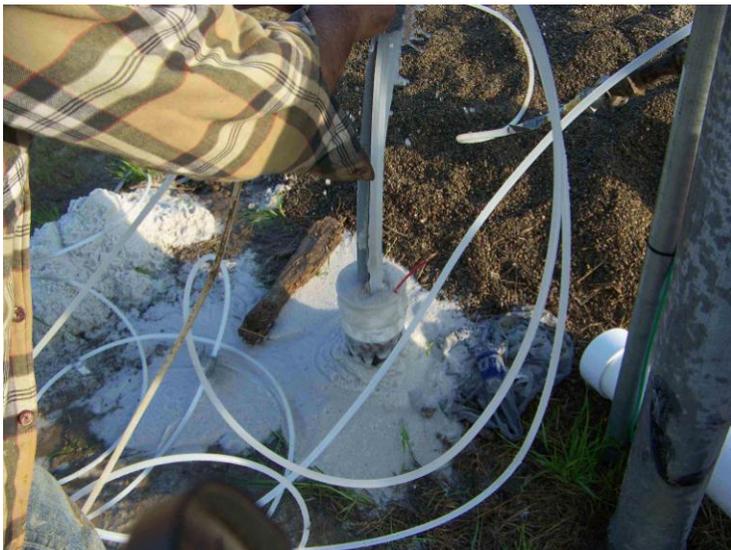
**FIGURE 7: Retrieval of inclinometer string by loosening sand backfill using water jetting.**

For retrieval, the sand backfill was loosened by pumping water through the bottom jetting tube and also using 0.5-inch (13 mm) PVC pipe for additional jetting from the top. Refer to Figure 7. However, extraction at the Fort Ann site ultimately required more pulling force and torque than recommended by the manufacturer, which will be a topic of further discussion.

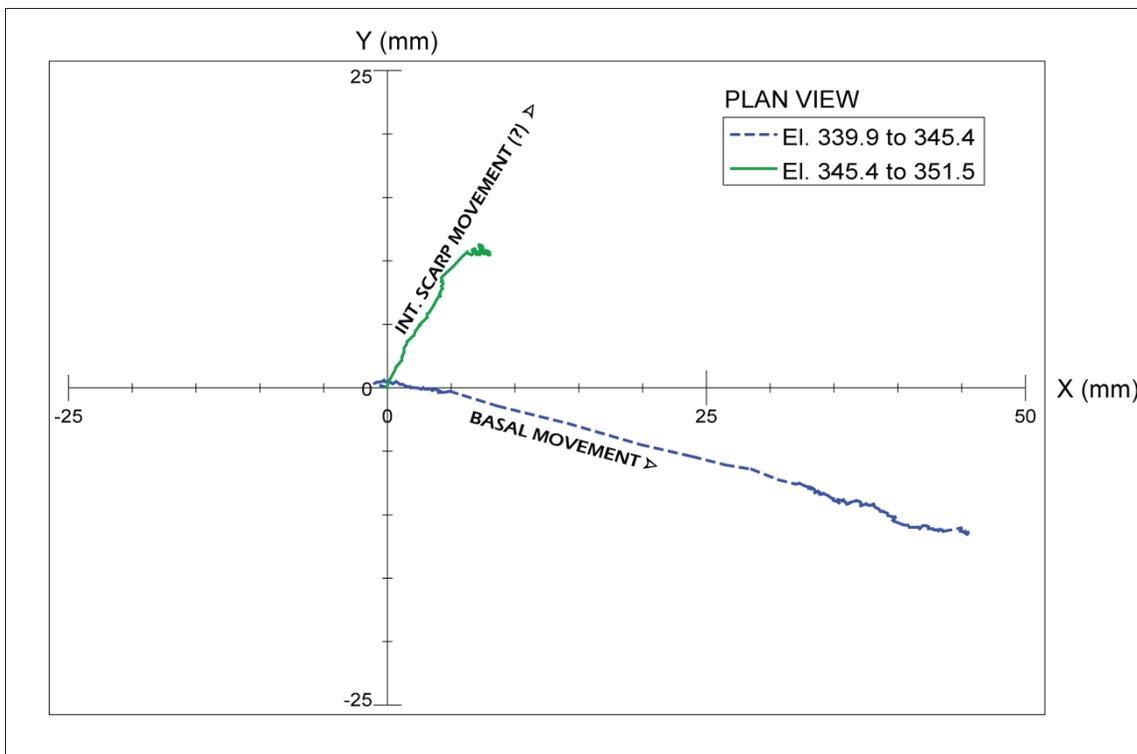
**FIGURE 8: Resultant direction of movement over selected elevation ranges – Springville**

Movement directions recorded by sensors at different elevations were significantly different from each other, (see Figure 8), and therefore twists in the inclinometer string were suspected during the monitoring of the Springville slide. However, there were neither insitu means to measure actual alignments nor means to determine whether damage or twists had occurred at the joints without removing the instrument from the borehole casing. After its extraction, the lower half of the instrument was found to be out of alignment by 3 to 4 degrees per joint. The cumulative effect was that the lower sensors were over 180 degrees out of alignment from the upper! It is postulated that the damage to the joints most likely occurred during prior extraction at the Fort Ann site, which required more pulling force than originally intended (the manufacturer's recommendation was 500 lbs (2.2 kN)). One lesson to be learned is that a field check should be performed on a retrieved instrument prior to each additional installation to verify sensor alignment and that all the components are functioning as originally intended. The manufacturer is reportedly now providing software for performing a field calibration of rotational alignment, although the authors have not yet had the opportunity to evaluate it. System improvements could also be made to provide improved durability. To this end, the manufacturer is now encasing the inclinometer string with steel braid to improve torque resistance.
